GRASSY TRAIL DAM AND RESERVOIR

MINING-INDUCED SEISMICITY

Summary Report, January 2008

MINING-INDUCED SEISMICITY
NEAR GRASSY TRAIL DAM AND RESERVOIR
Carbon County, Utah

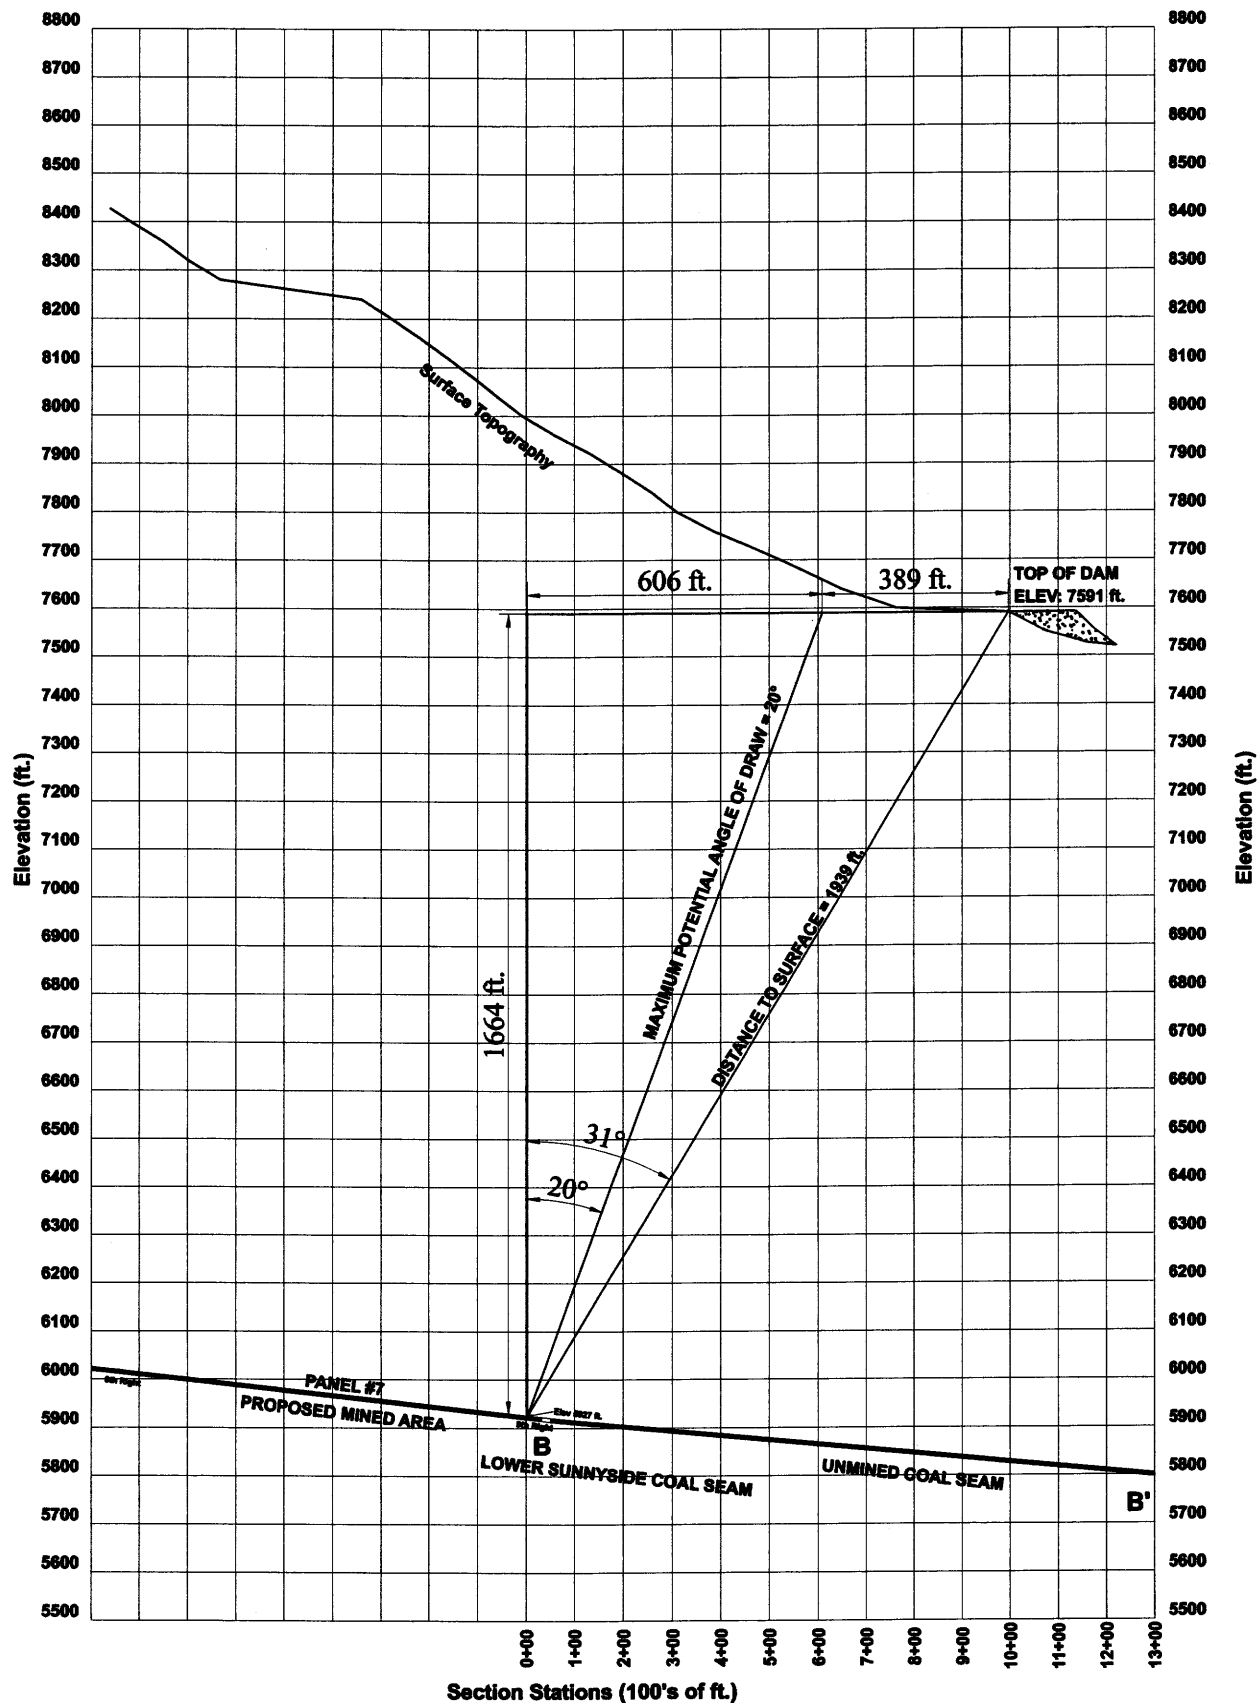
Figure 3 shows the locations of West Ridge Mine Panels 6 and 7 relative to Grassy Trail Dam and Reservoir. This figure includes the dates of completed mining for about half of Panel 6, as well as the dates that mining in each area through Panel 7 was expected to occur, as of June 2005. Figure 4 is a cross section illustrating the location of Panel 7 with respect to the dam. It will be noted that the coal seam to be mined lies 1664 feet vertically below the crest of the dam. The nearest point on Panel 7 lies 995 feet horizontally west of the dam's right abutment.

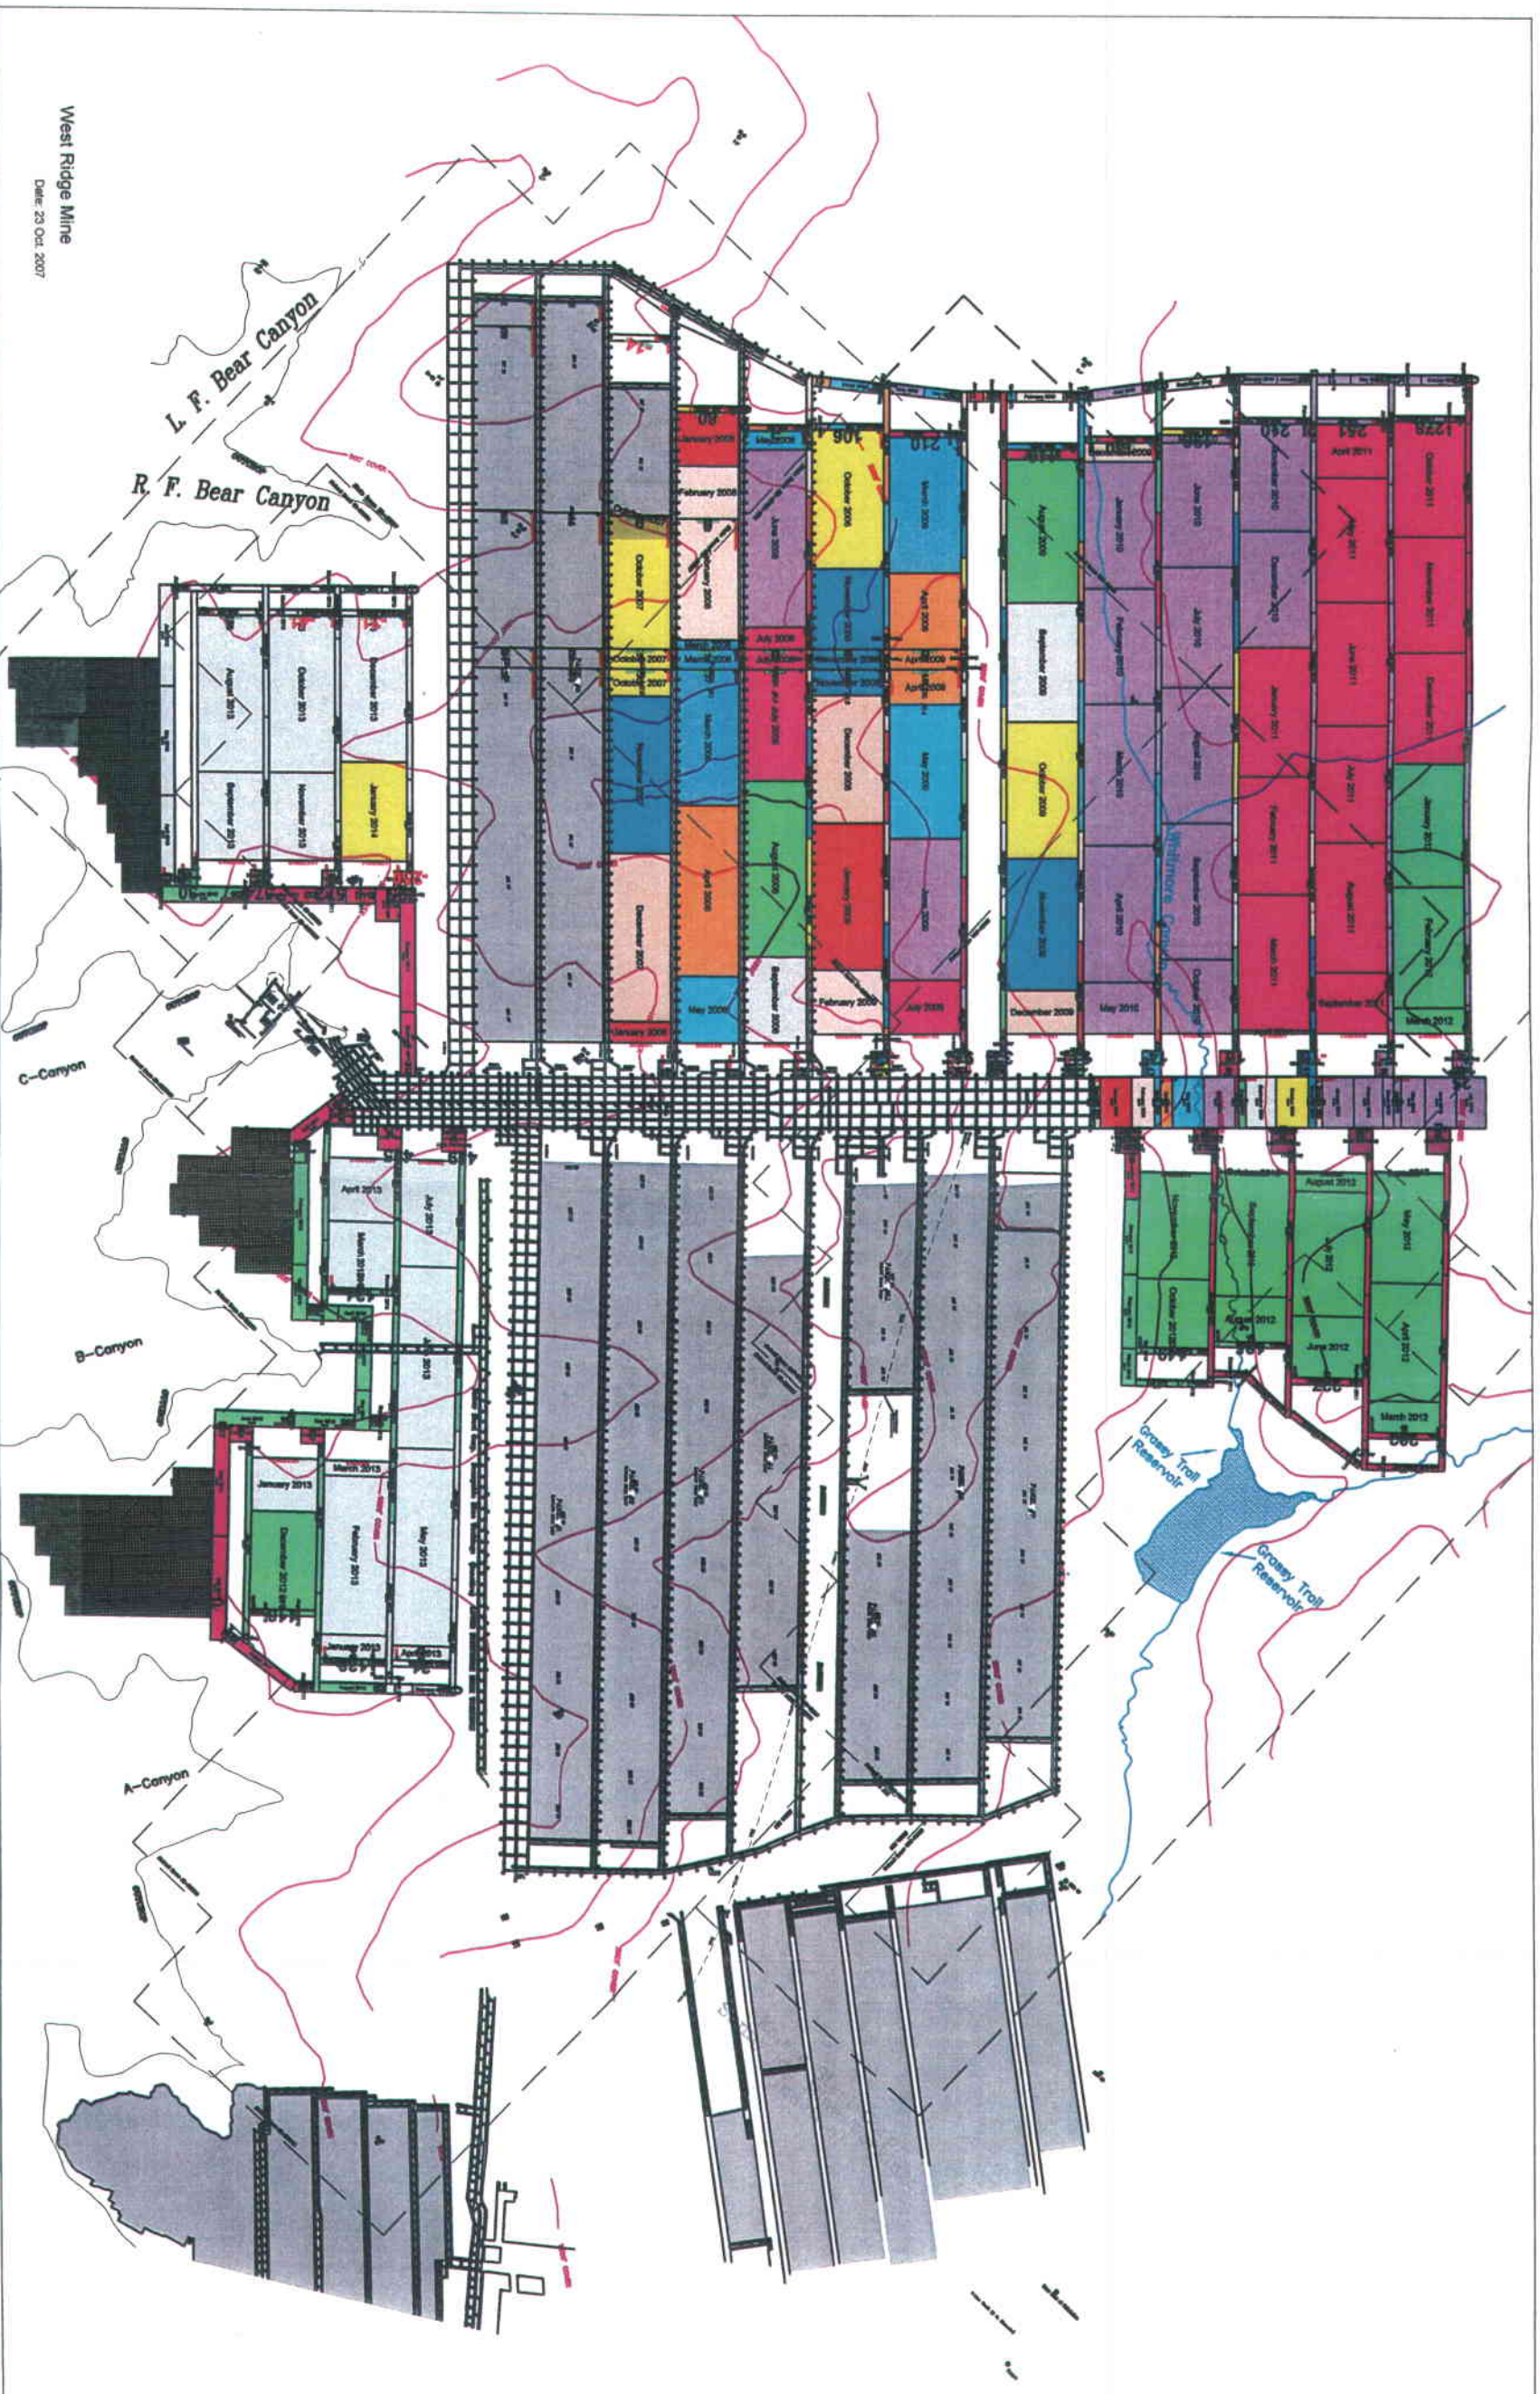
Figure 6

Following completion of Panel 7, the mining operation moved to a new panel located between 1.5 and 3 miles west of the reservoir (north of the previously-mined panels). The projected areas to be mined in the next five years are shown on Figure 6. From this figure, it appears that future mining will gradually progress in an easterly direction, moving closer to the reservoir. The potential future mining of panels located as close to the reservoir as Panels 6 and 7 is not projected to occur until the year 2012.
